JSC/EC5 U.S. Spacesuit Knowledge Capture (KC) Series Synopsis

Topic: TPS Inspection and Repair

Date: February 23, 2012

TPS Inspection & Repair

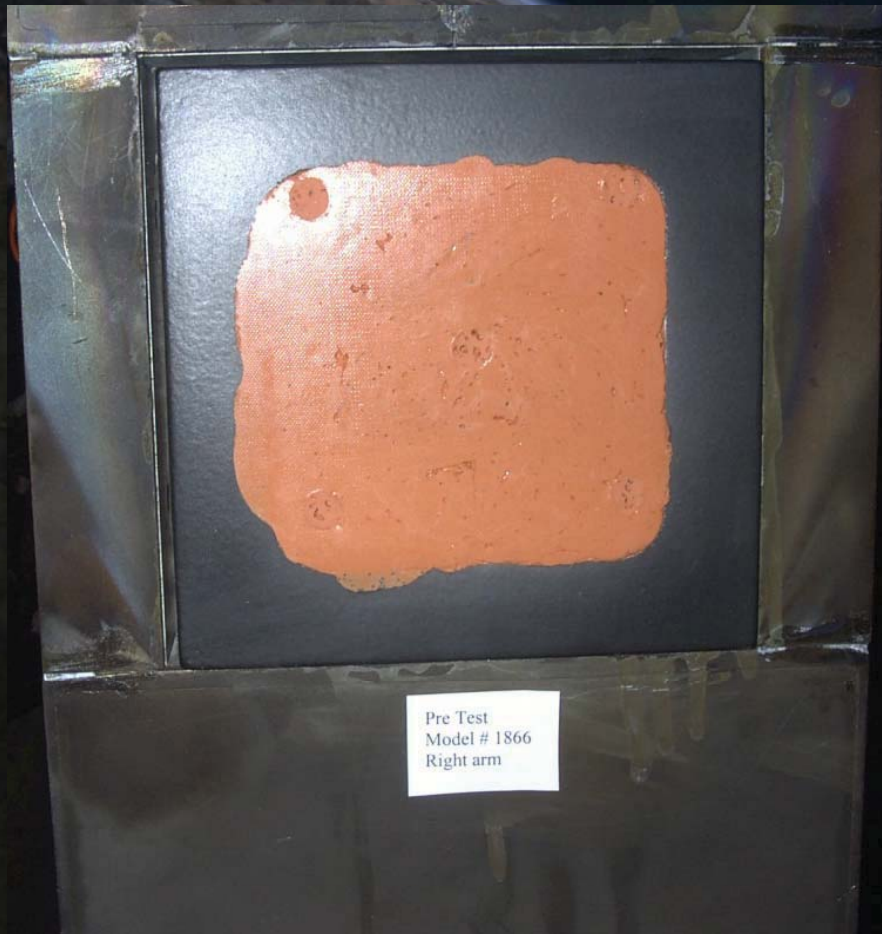
Tile Repair & STA-54 Uncertainties

- Perforated Membrane vs. "Open Technique"
- Swelling & Bubbling
- Uniformity of Density
- Char Layer Stability
- Operational Complexity
- Test Fidelity Concerns (1-G settling)

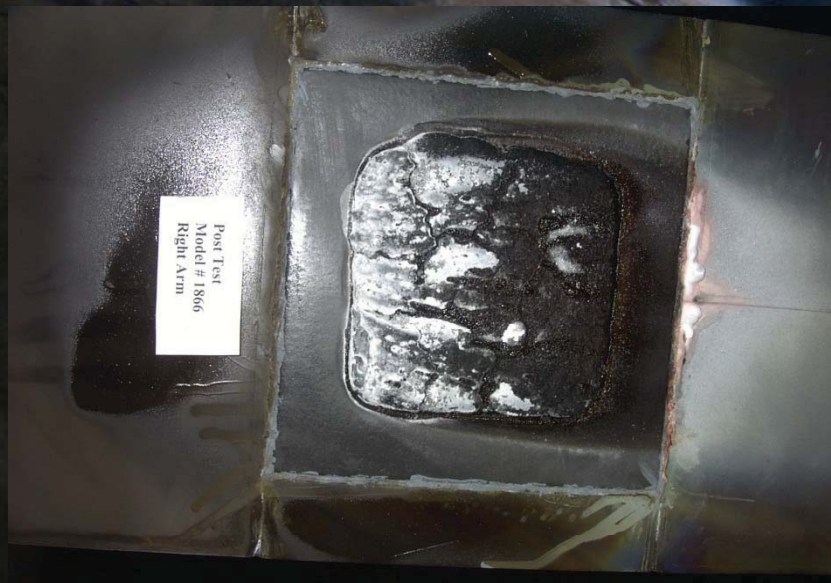
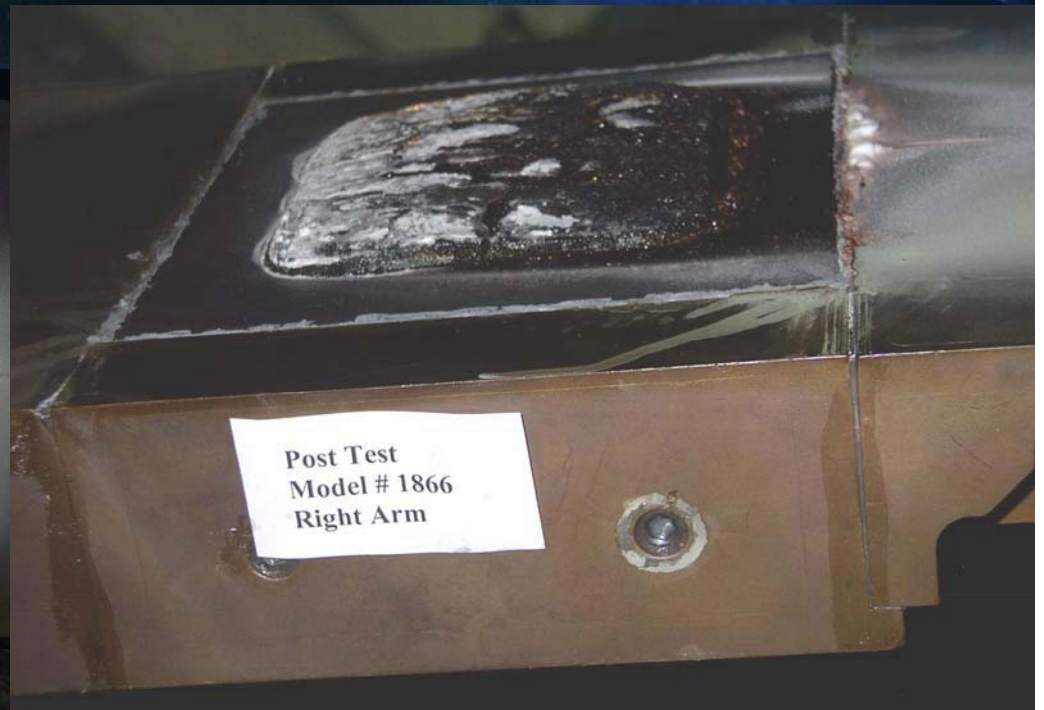
Arc Jet Testing

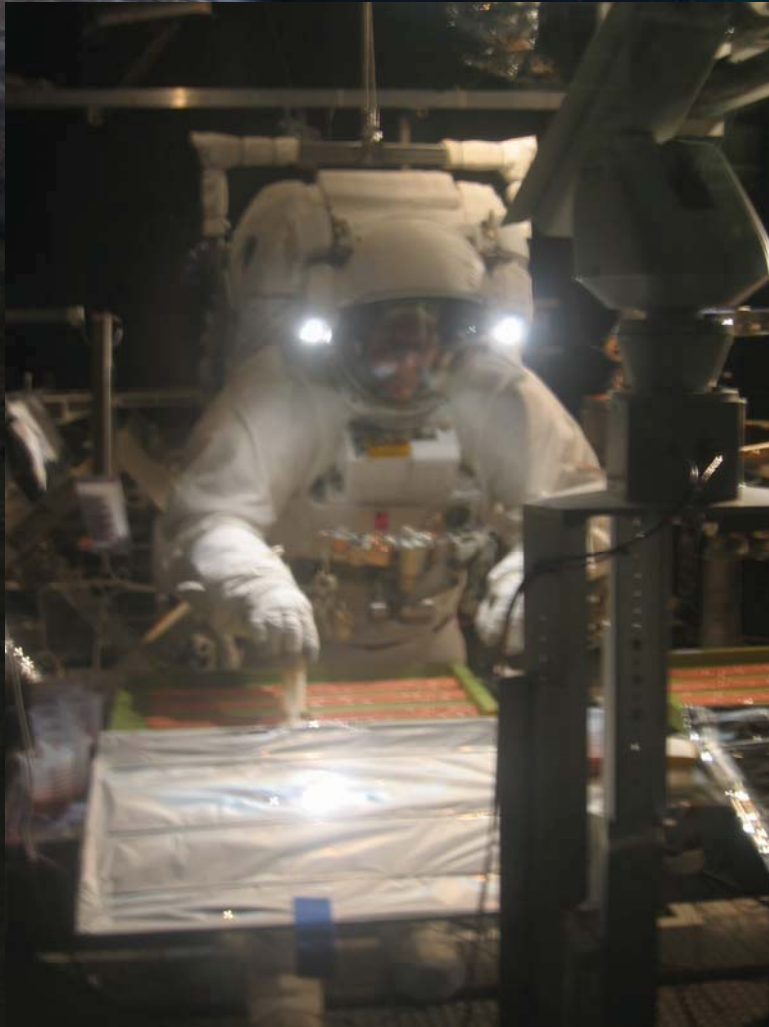
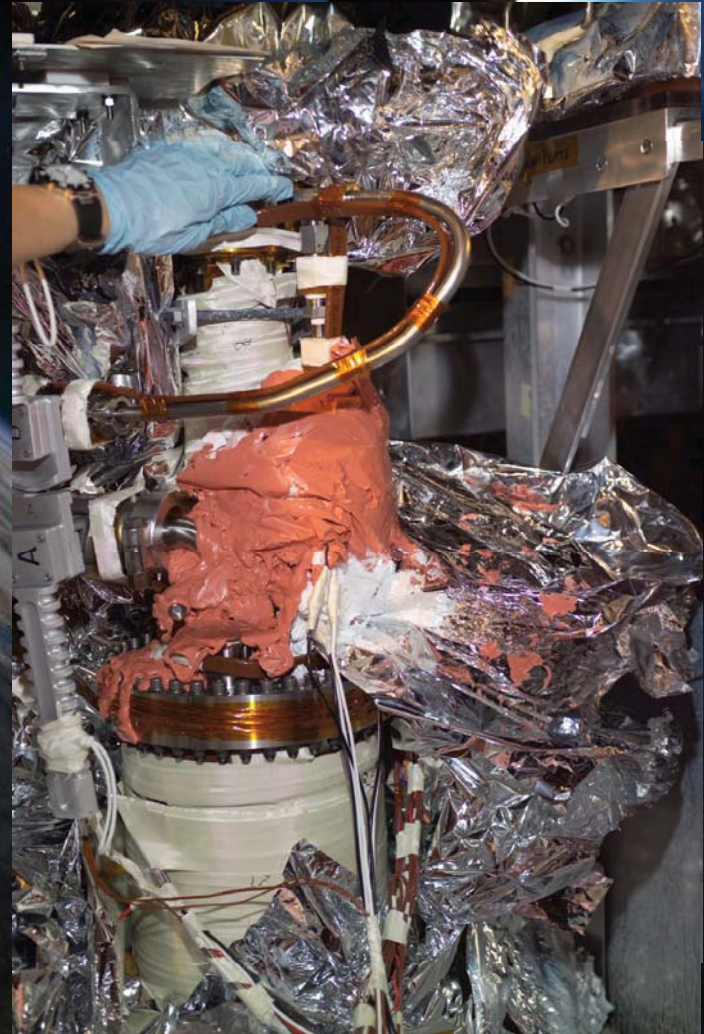
Human Thermal Vacuum Testing

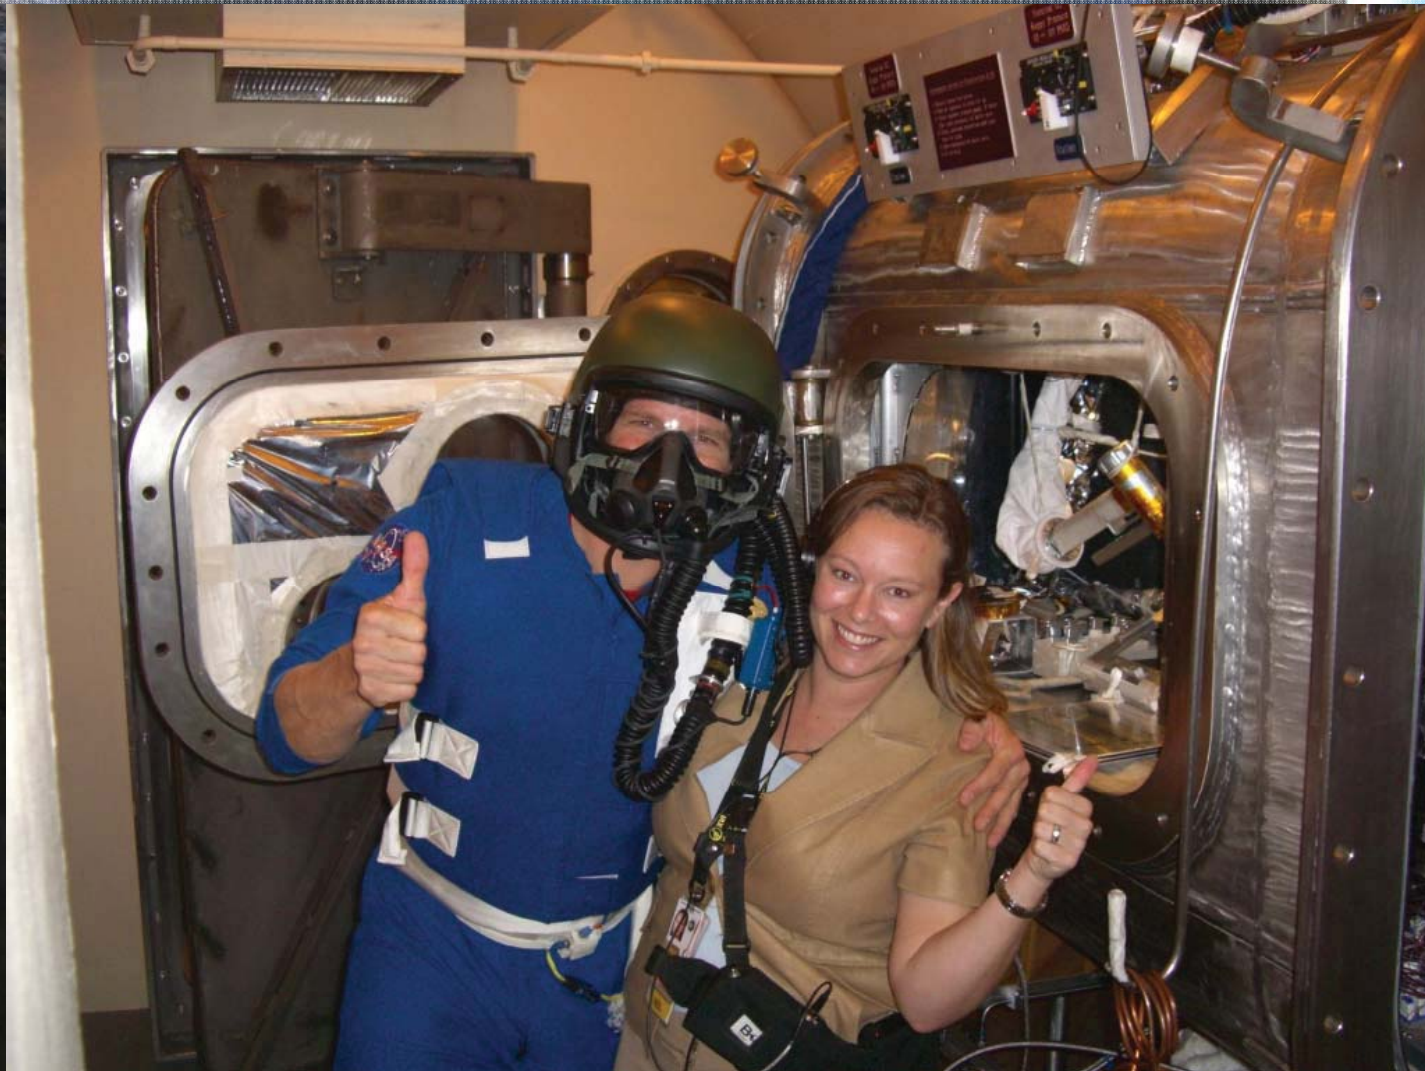
Dual Glovebox Thermal Vacuum

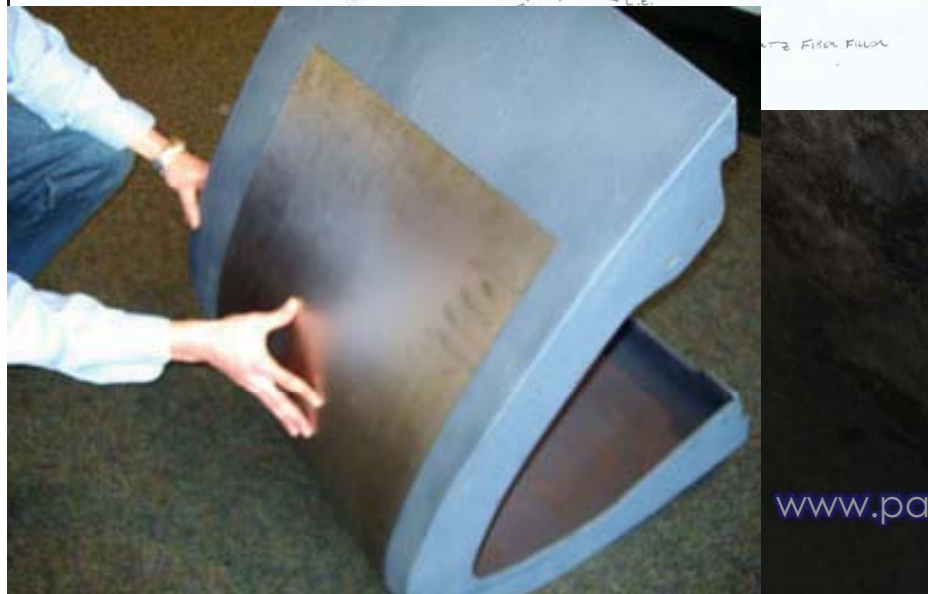
RCC Repair Strategies

- Fillers/Caulks
- Plugs
- Balloons
- Overwraps

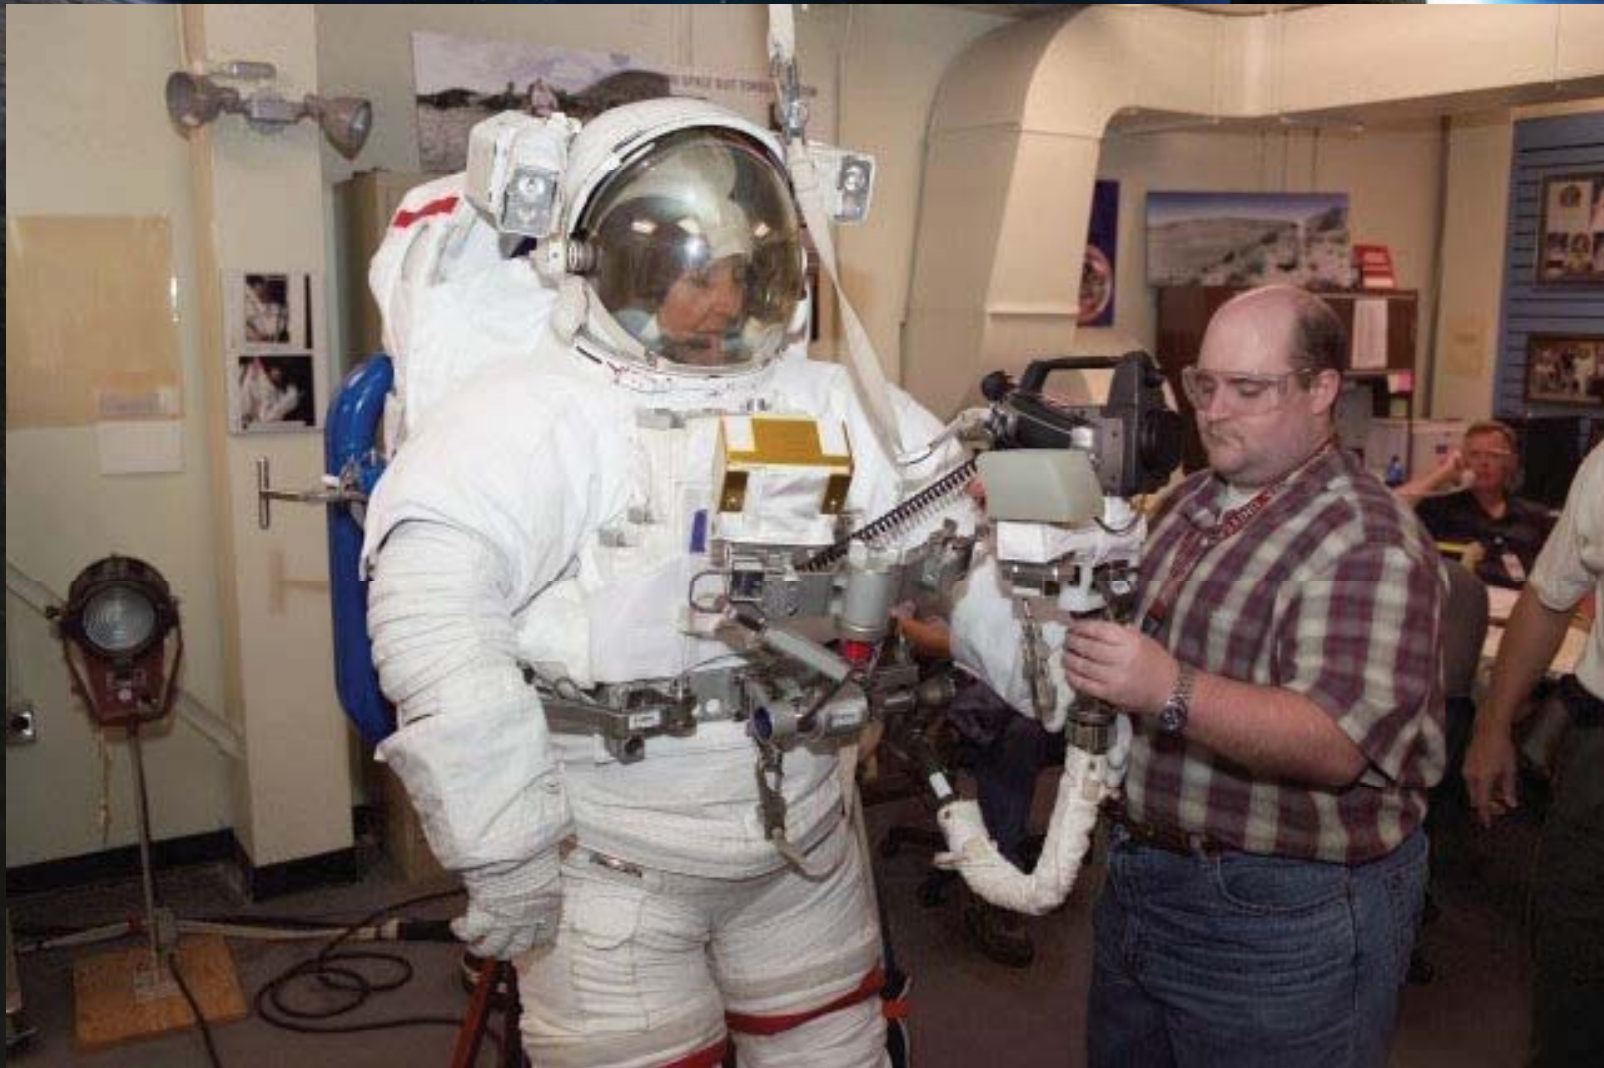
EVA Inspection Techniques

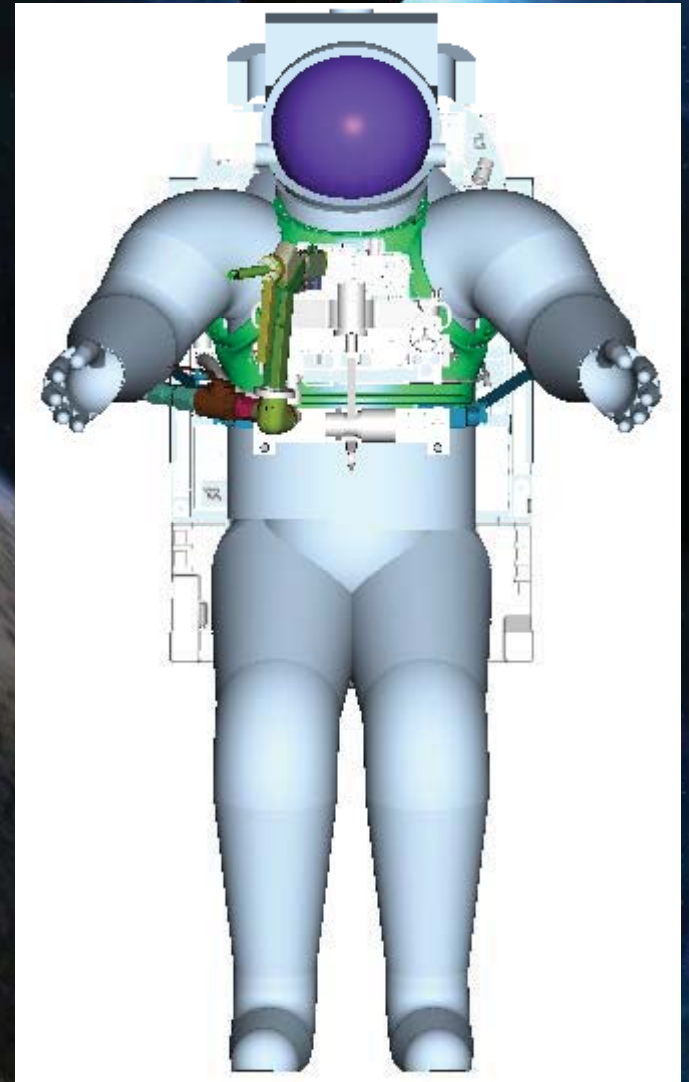
CIPPA Front/Back Views

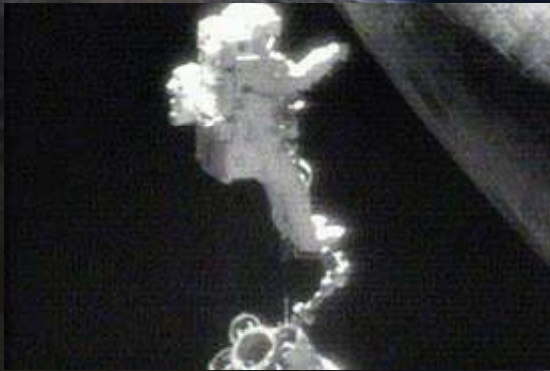
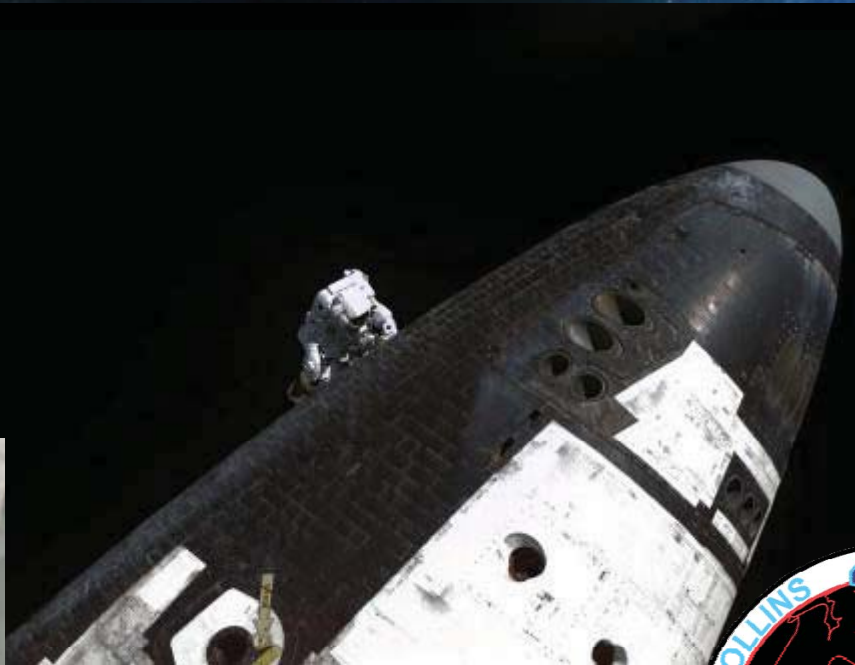
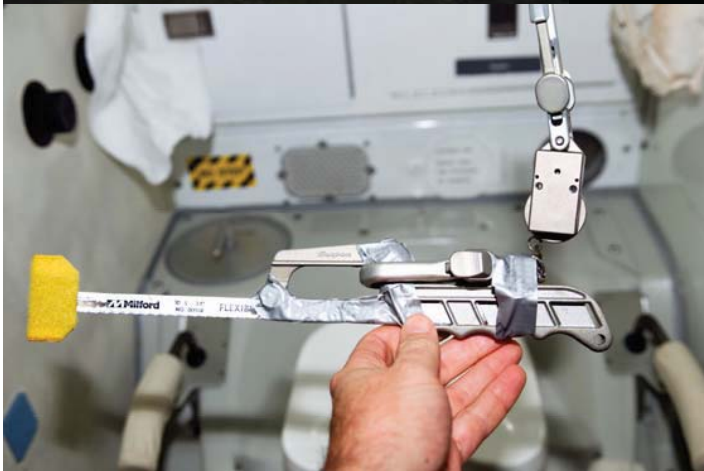
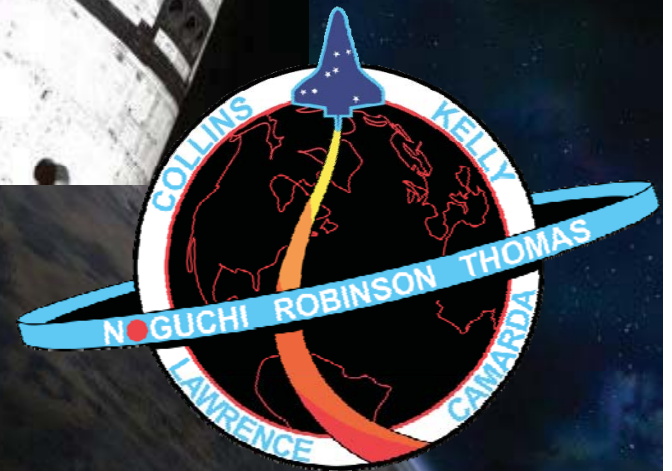
STS-114 Gap Filler Experience: Stevie Ray Robinson & Soichi Noguchi

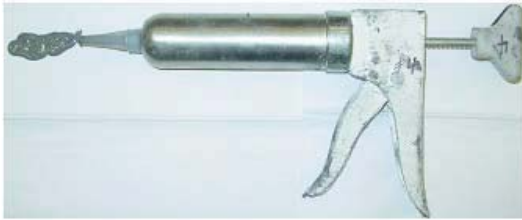
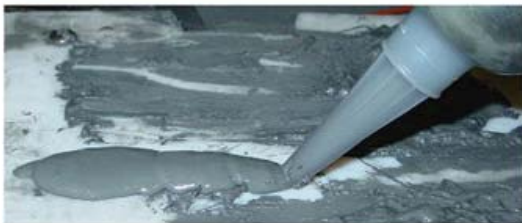
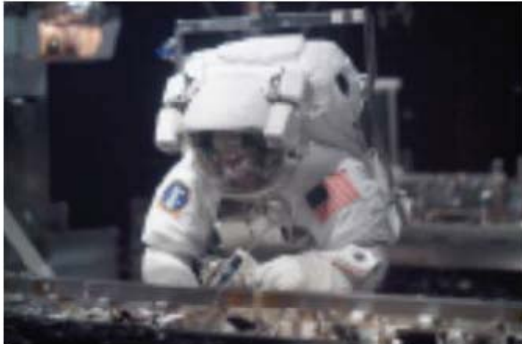
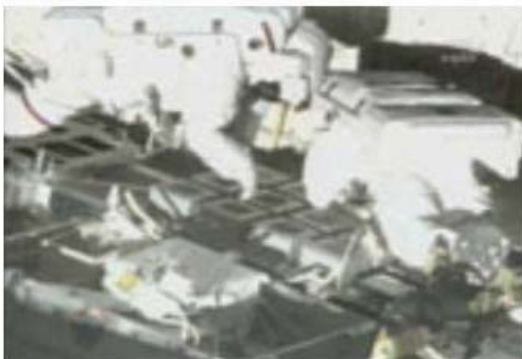
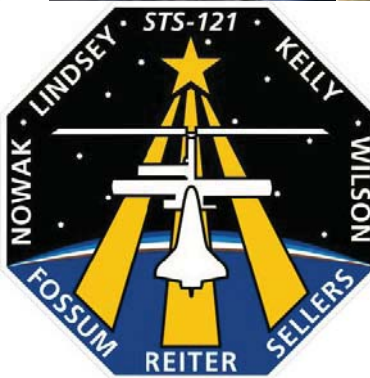
STS-121 RCC Repair DTO (NOAX ceramic): Mike Fossum & Piers Sellers
